Re: Draft Drum Mine Reclamation/Closure Plan

**RECLAMATION & CLOSURE PLAN
FOR THE
DRUM MINE
MILLARD COUNTY, UTAH**

December 1998

**Prepared for
Western States Minerals Corporation**

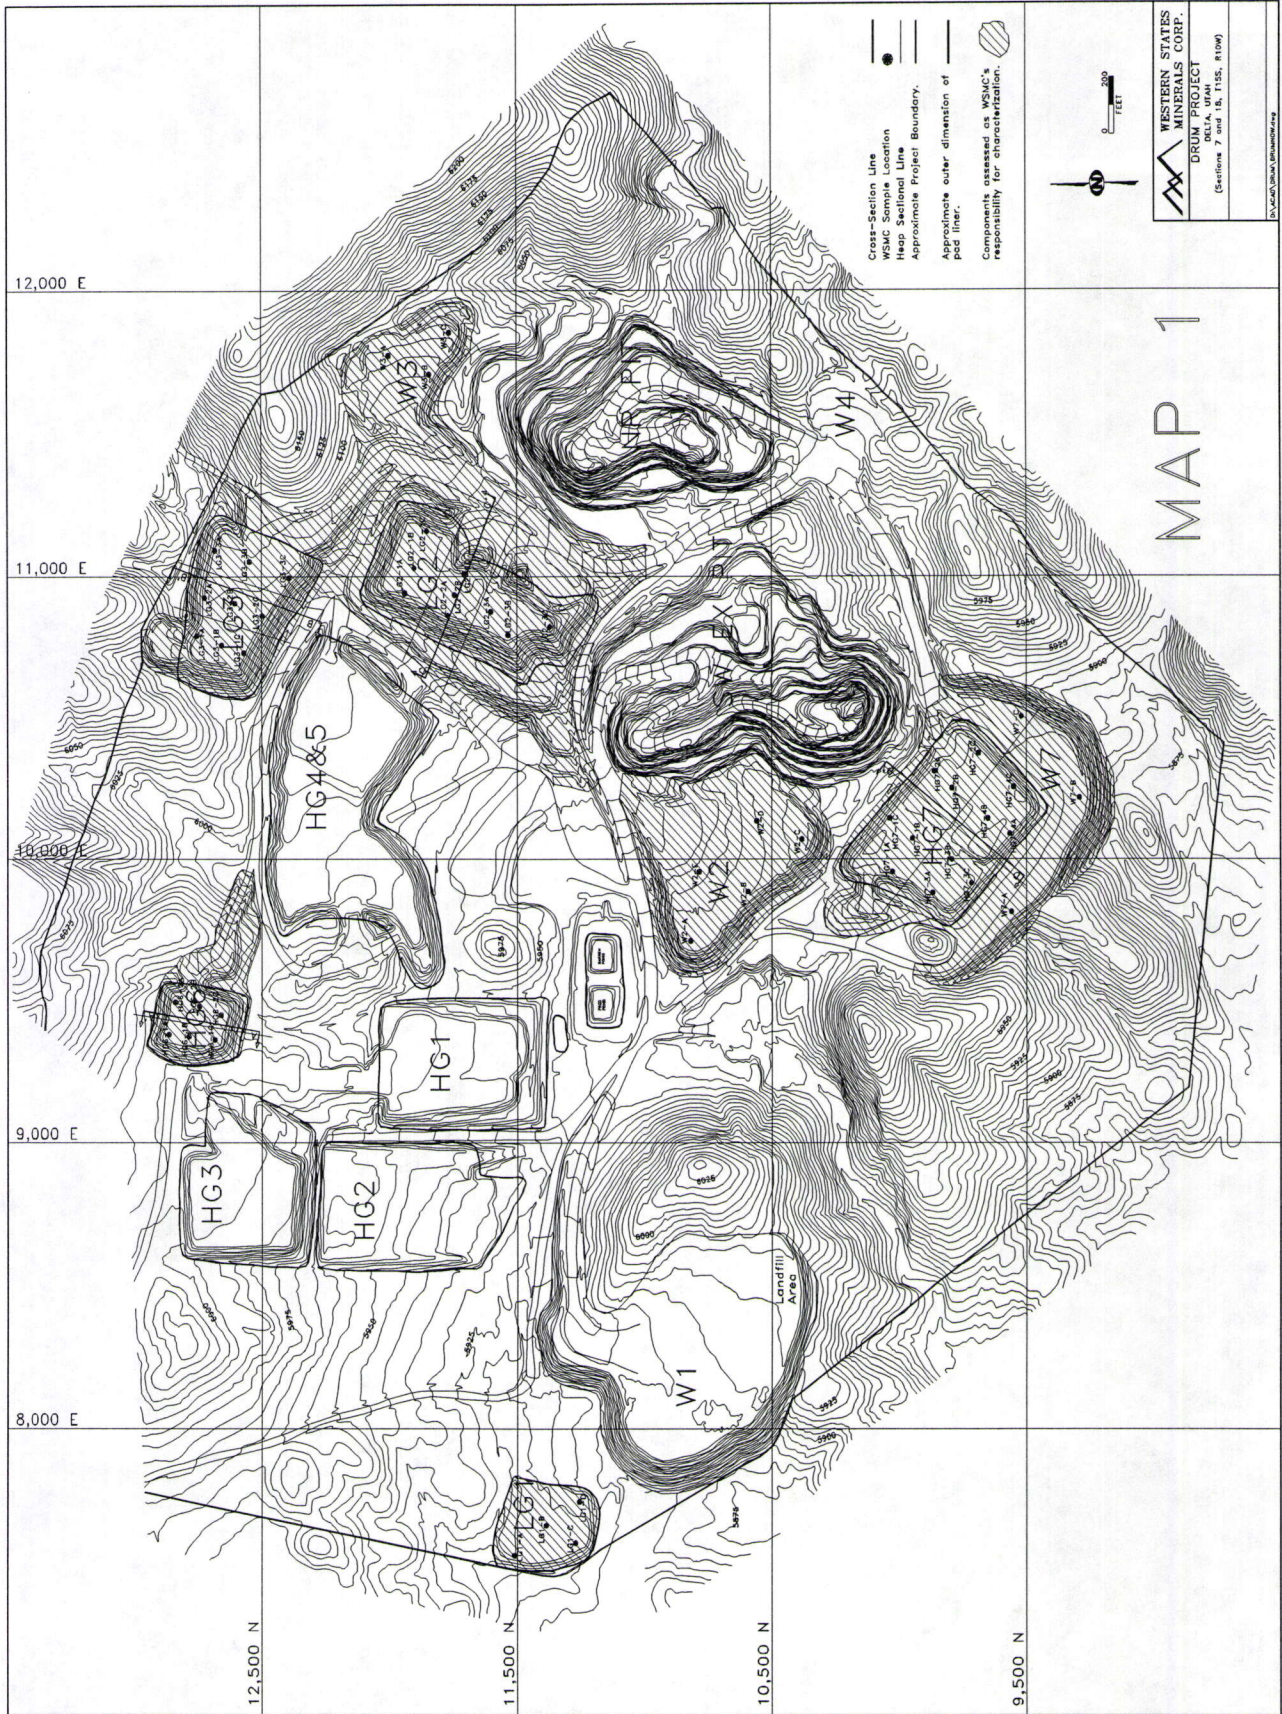
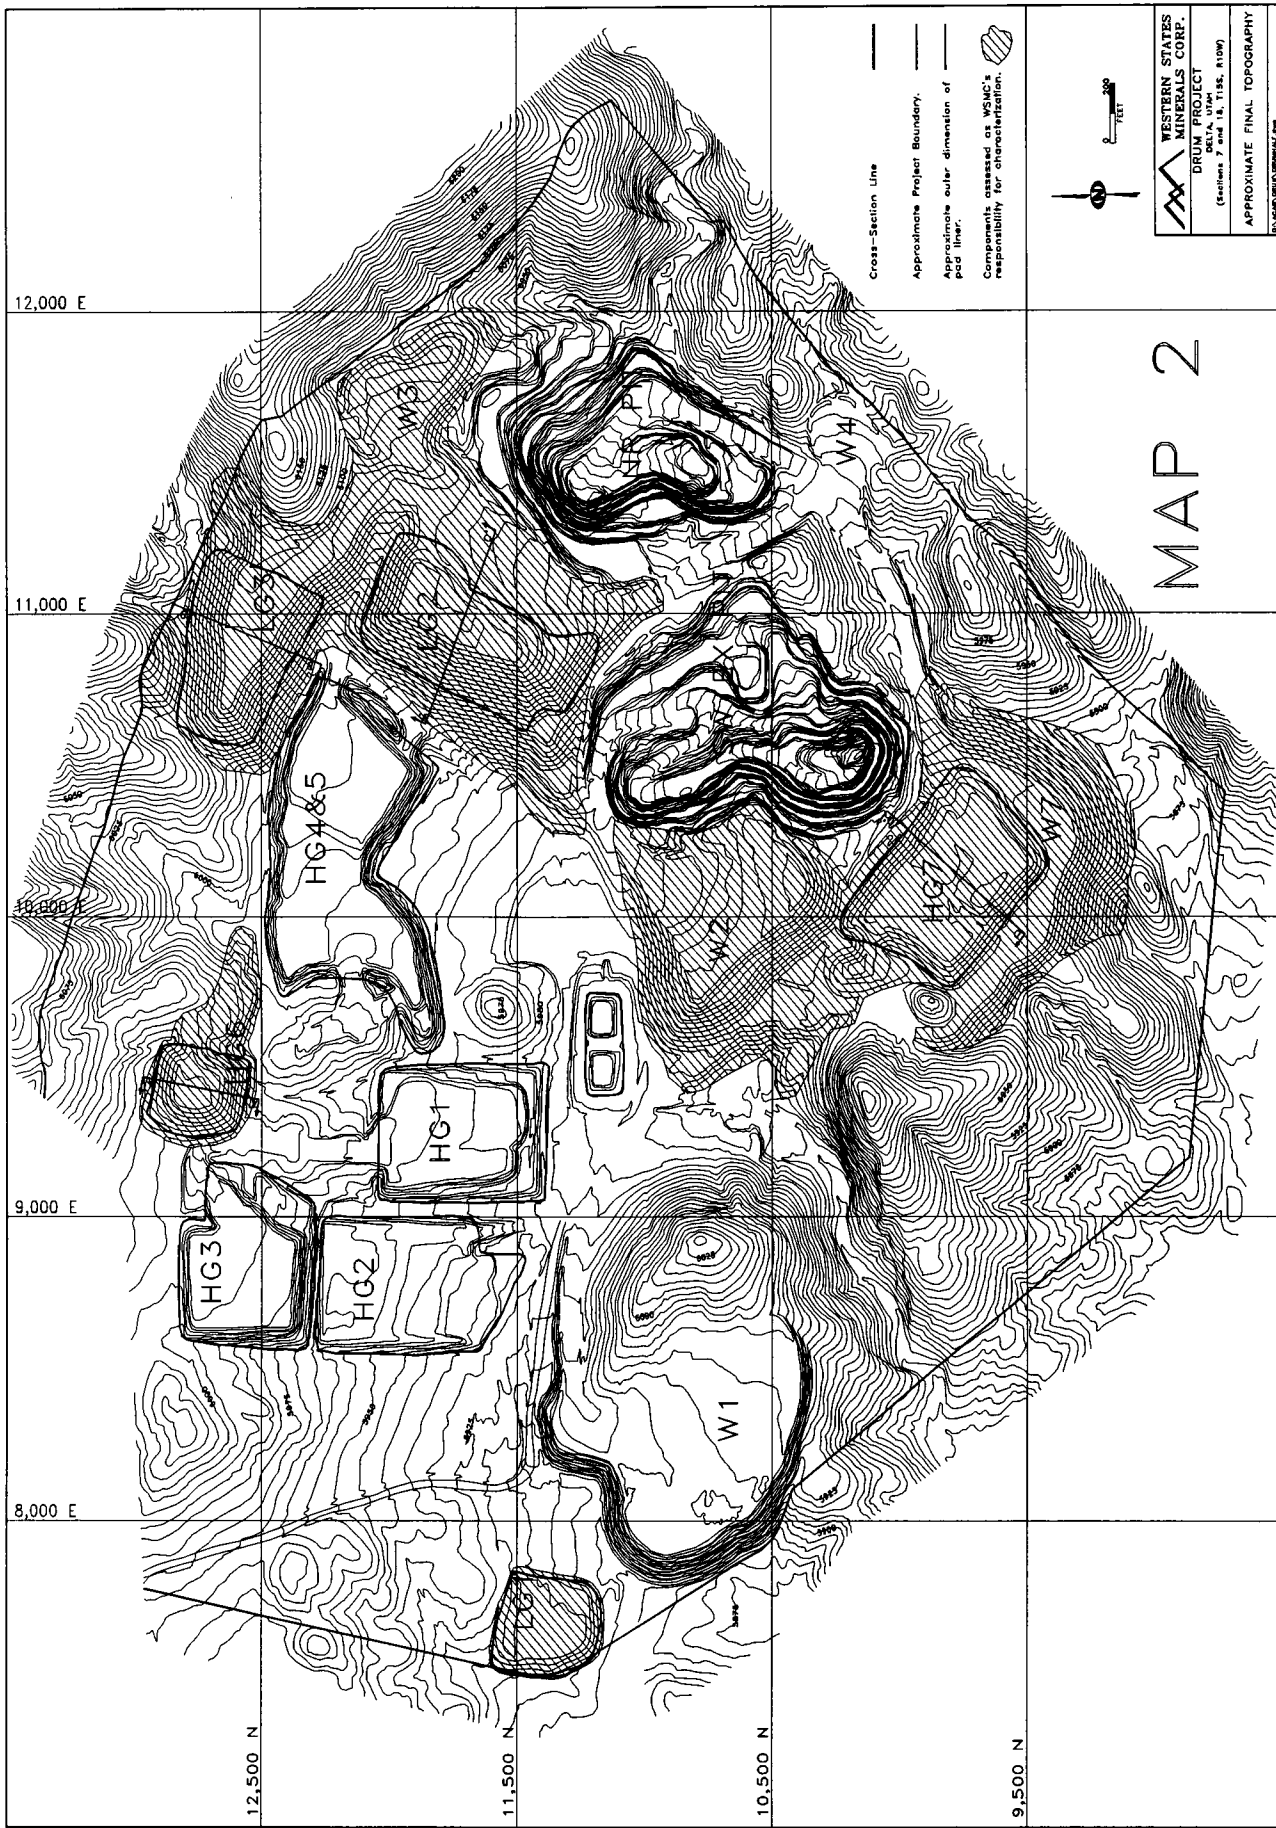
CROSS SECTIONS OF HEAPS

Approximate liner location
Final Topography (Slope - 3H : 1V)
Current Topography
Original Topography
